Subject:**Report on "Evaluation of Coating Application on Safe Tool prepared surface ."**

Evaluation of Coating Performance of various coatings on the surface prepared with Safe Tools.

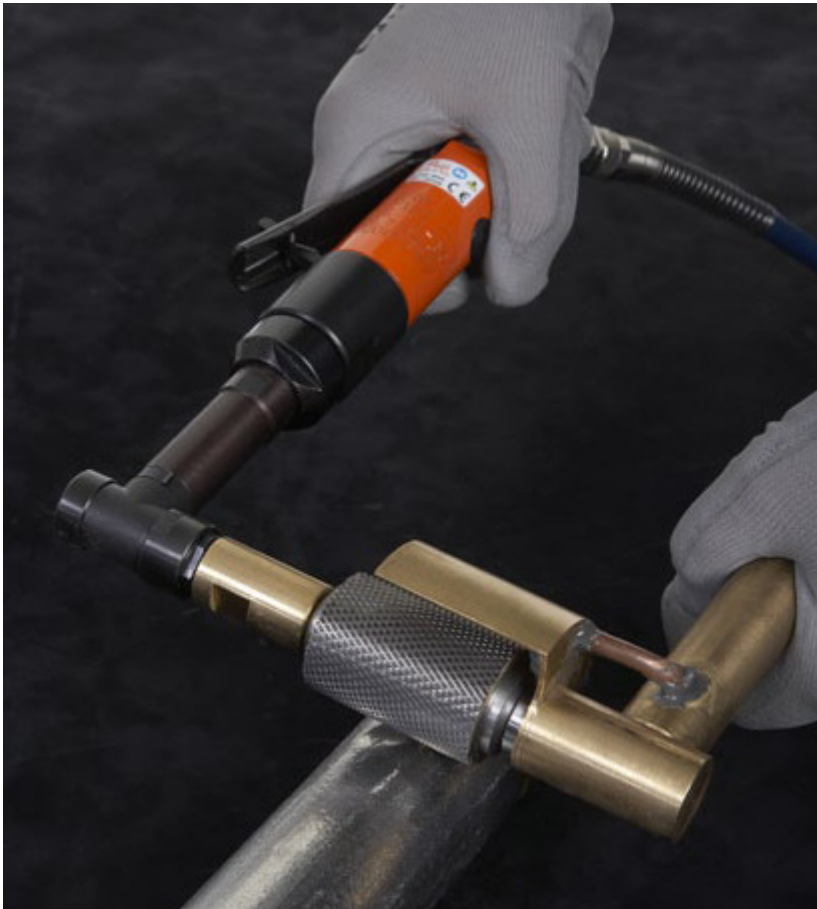
Tool Number A-009 at 2000 RPM

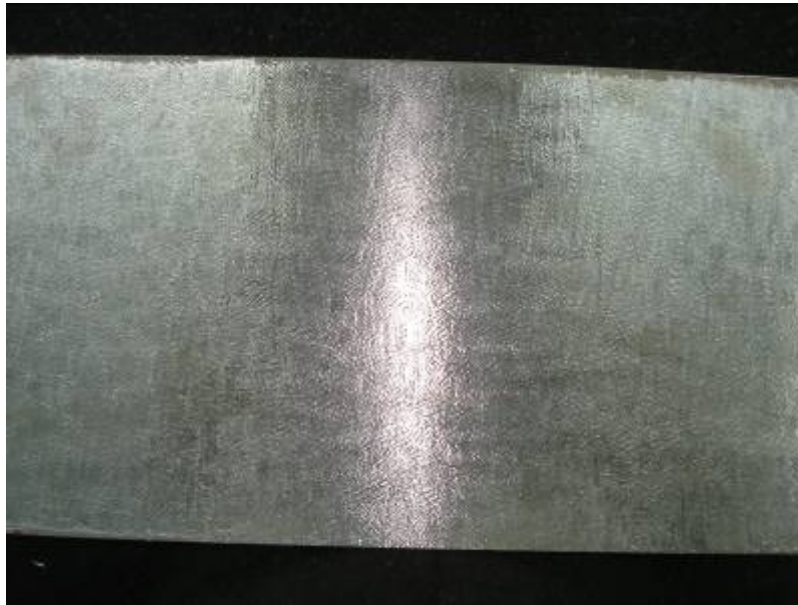
Surface prepared with Safe tools nearing to SA-3 or NACE -1 used for the application of Interzinc 12.

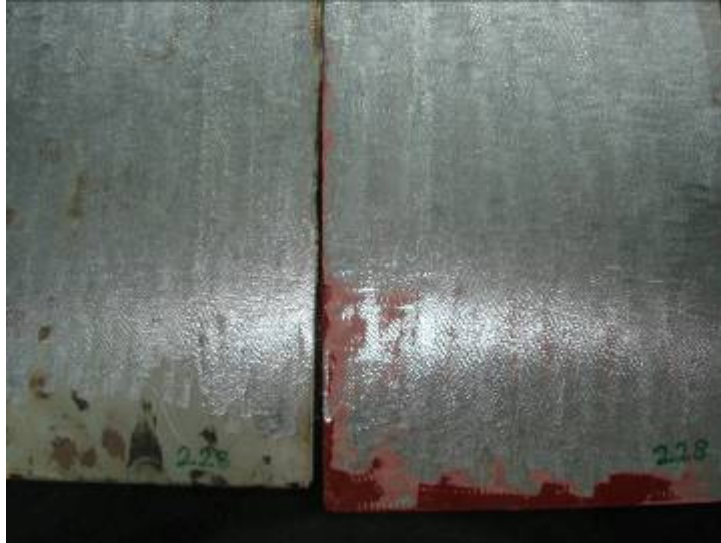
Purposely prepared for application of Intertherm 228

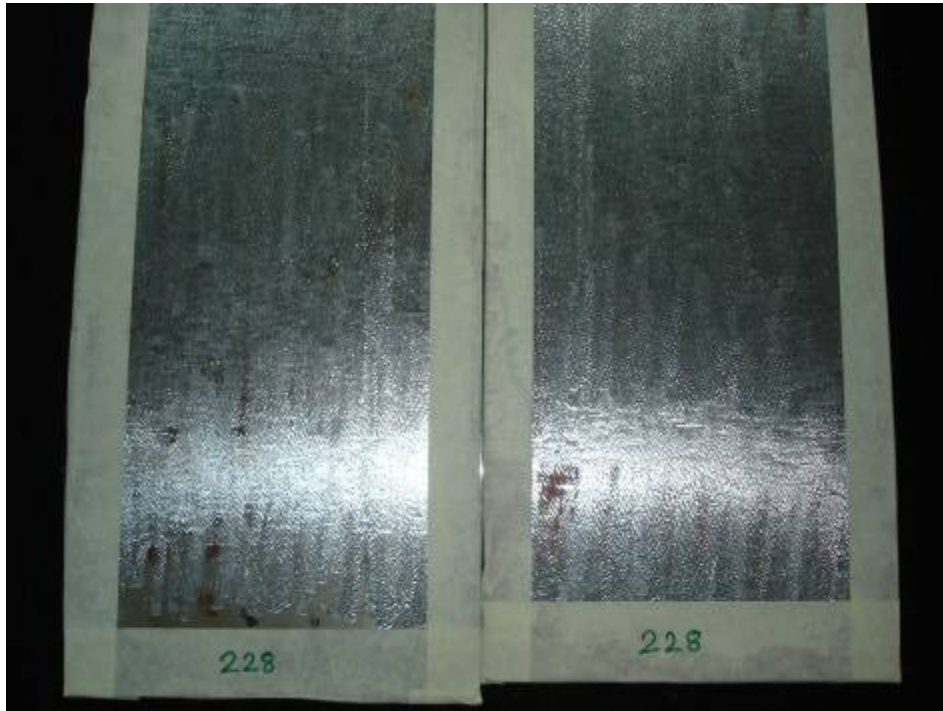
Purposely prepared for the application of Interzone 954

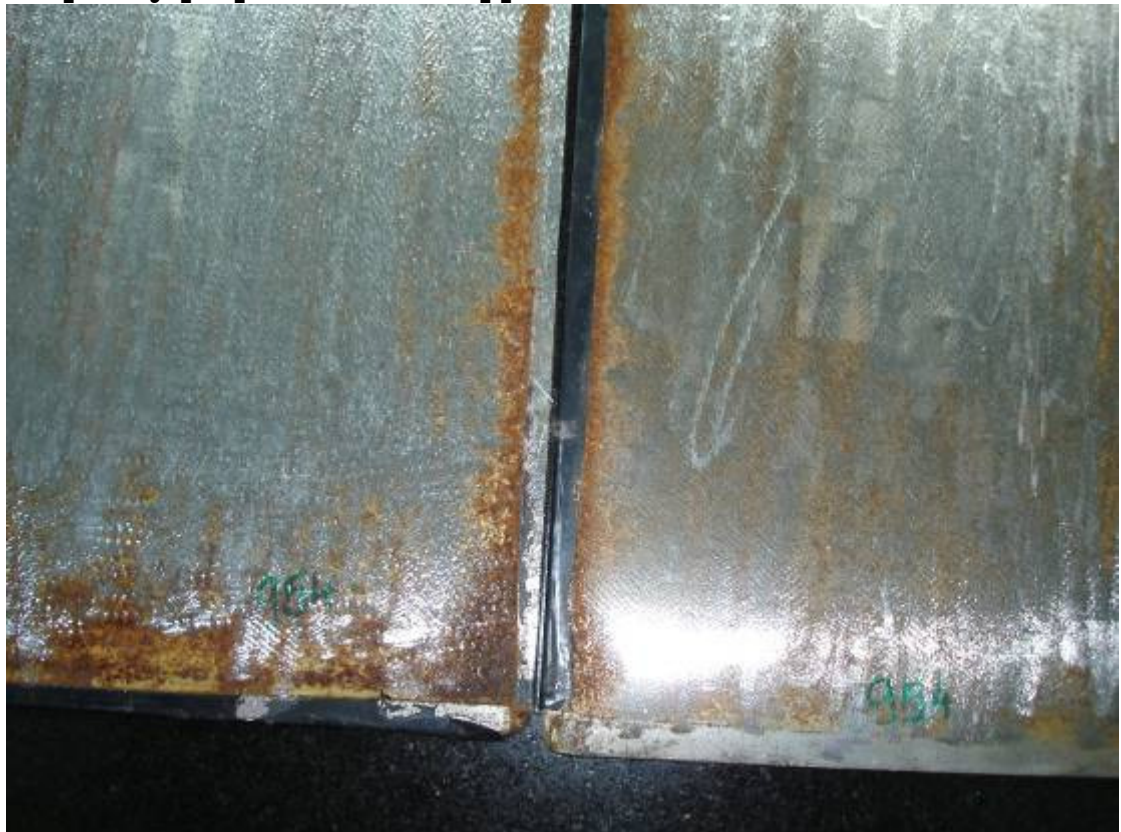
Purposely prepared for the application of Interzone 954

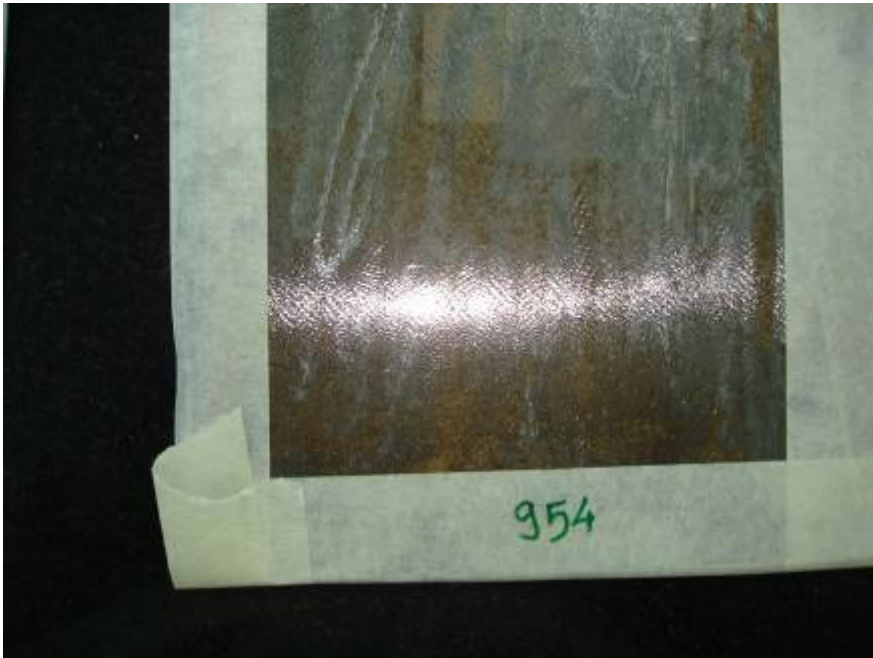
Surface Prepared for Interline 850

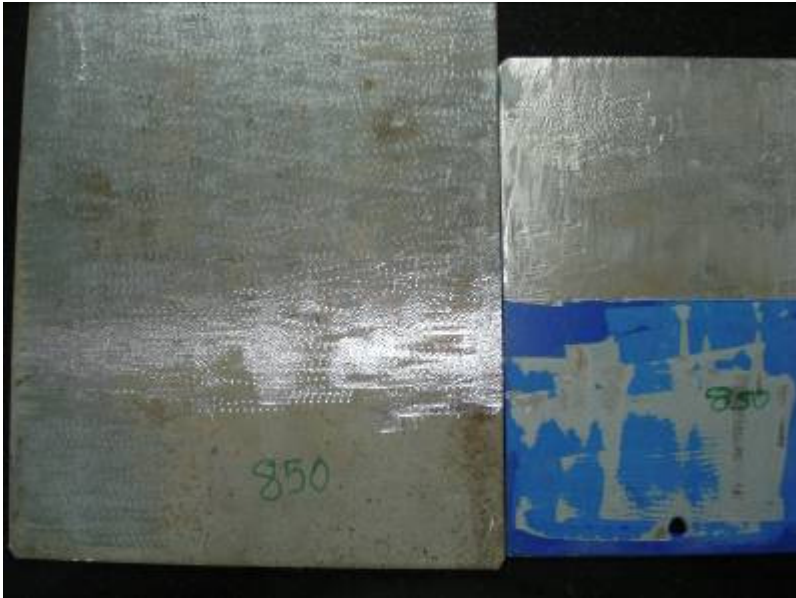
Surface Prepared for Interline 850

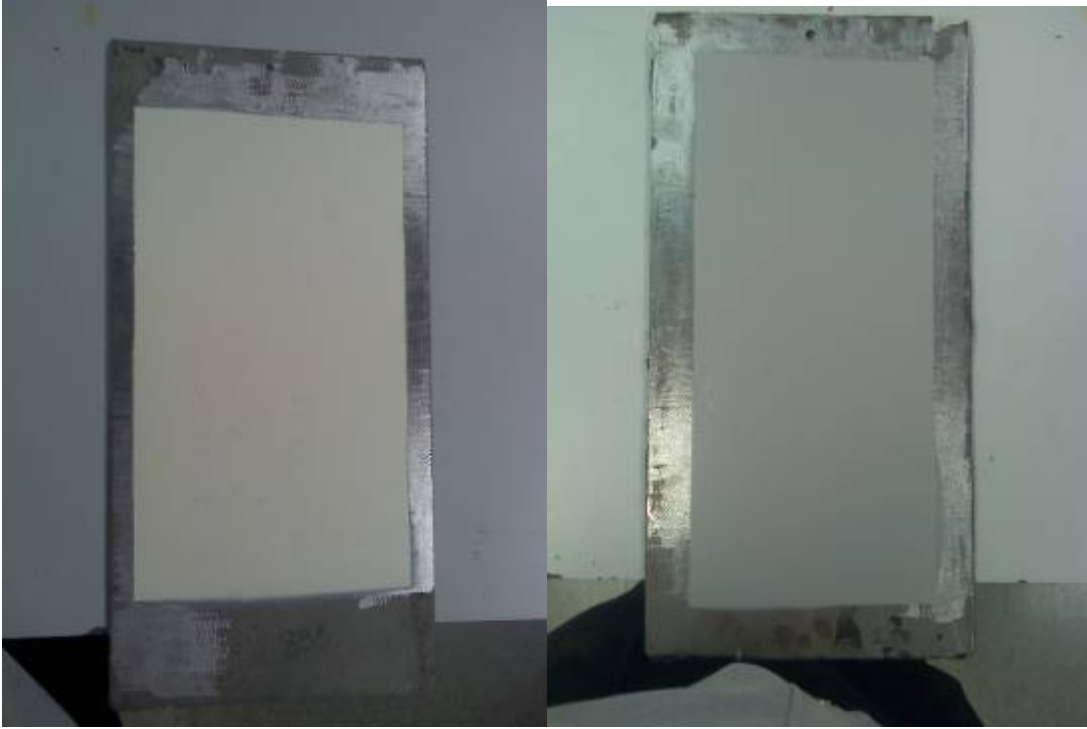
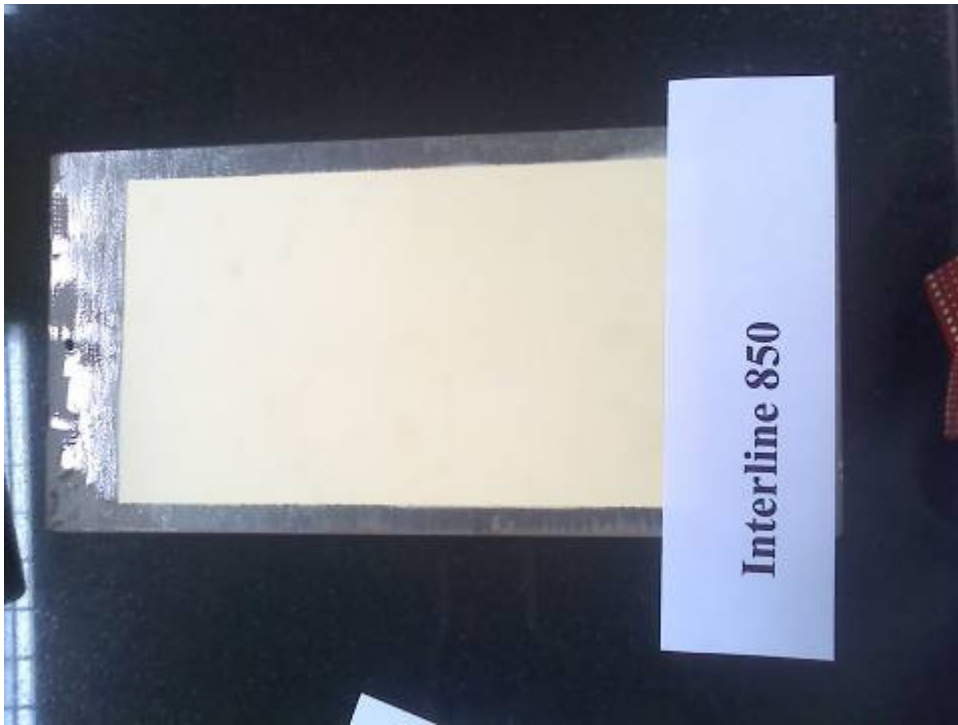
Various Coated Panels after Drying for 24 Hrs @ 25 +/- 3°C.

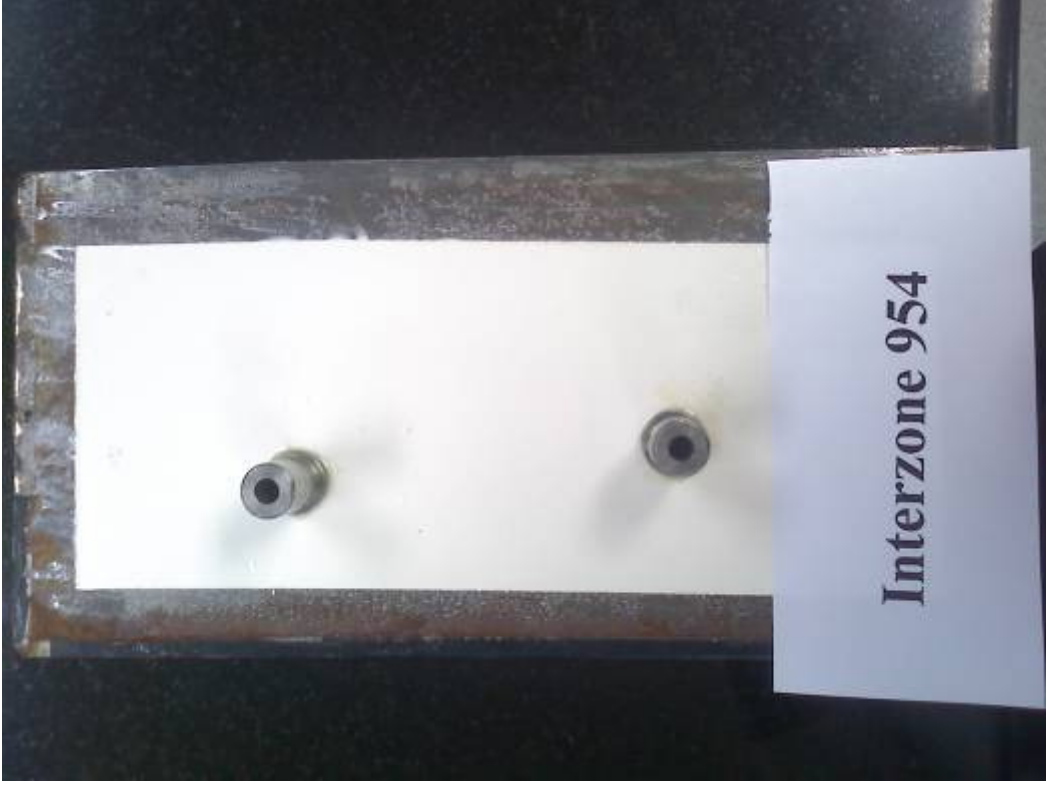
Interzone 954

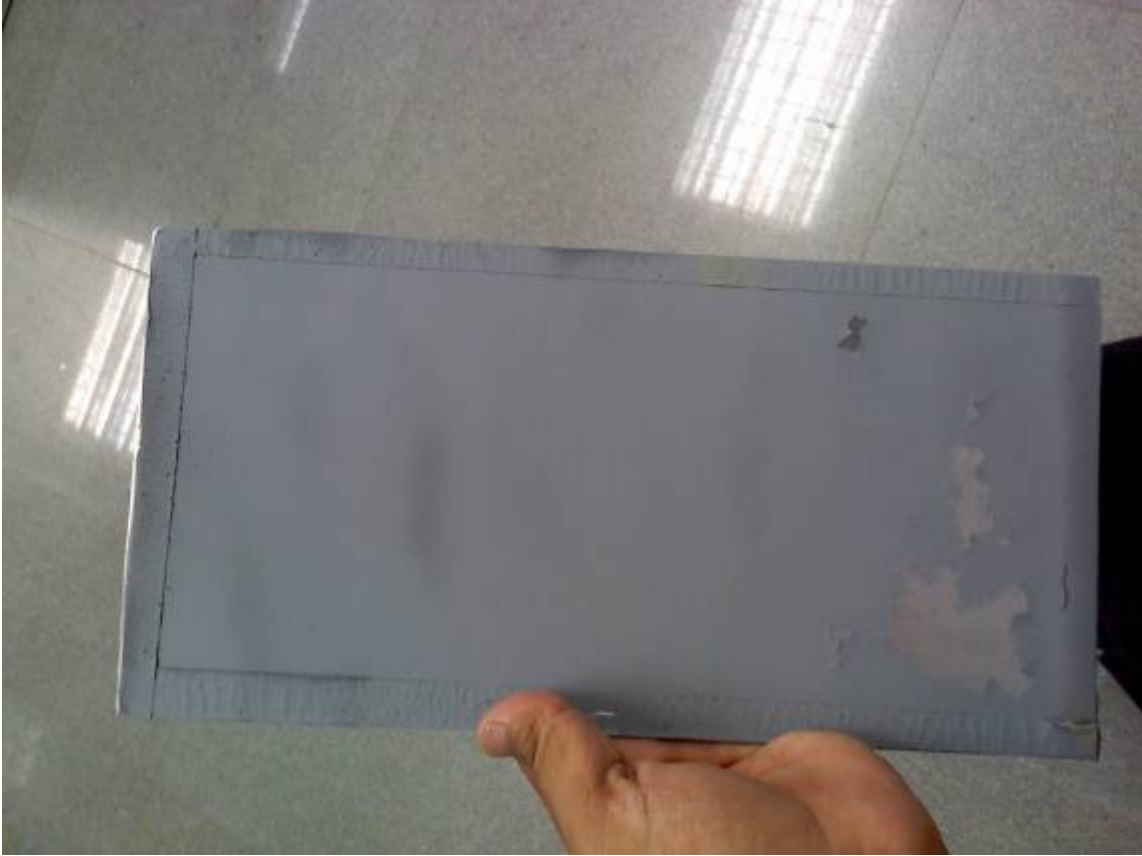
Interzinc 12 after Mud Cracks

Area where under mud cracks was as clean as it was before application for which is expert opinion need to be taken. This was experienced earlier on the Blast Cleaned Surface that whenever there are mud cracks the surface under mud cracks at least show the flash rust, Hence in this case expert opinion needed.

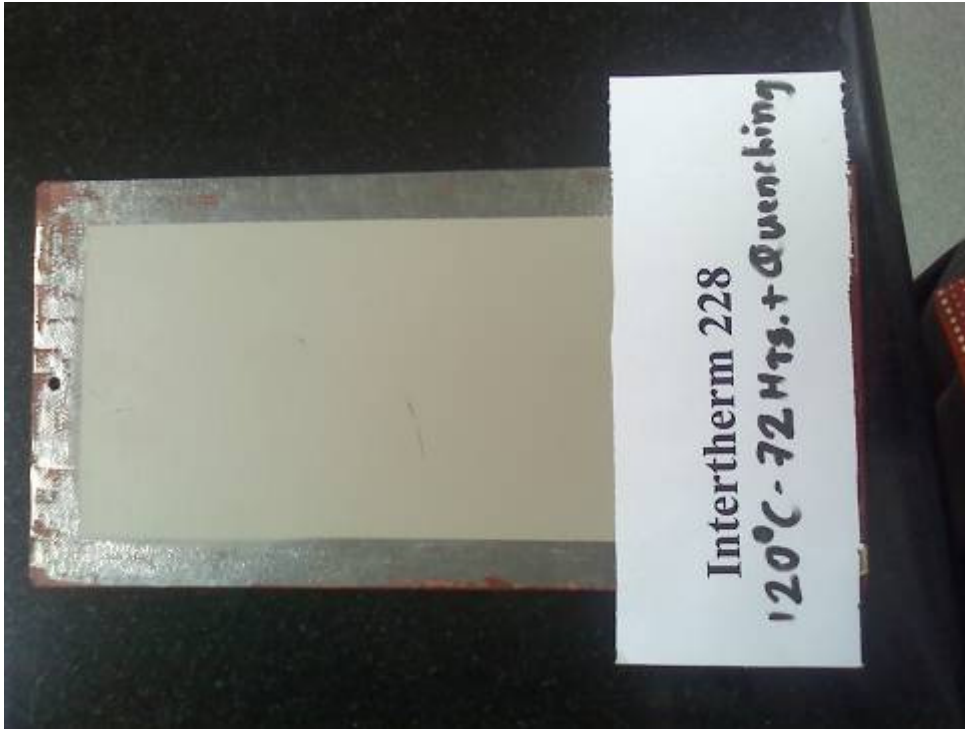
Intertherm 228 after 120°C 72 Hrs + Quenching + 48 Hrs @ 120°C & Quenching + 72 Hrs at Room Temperature

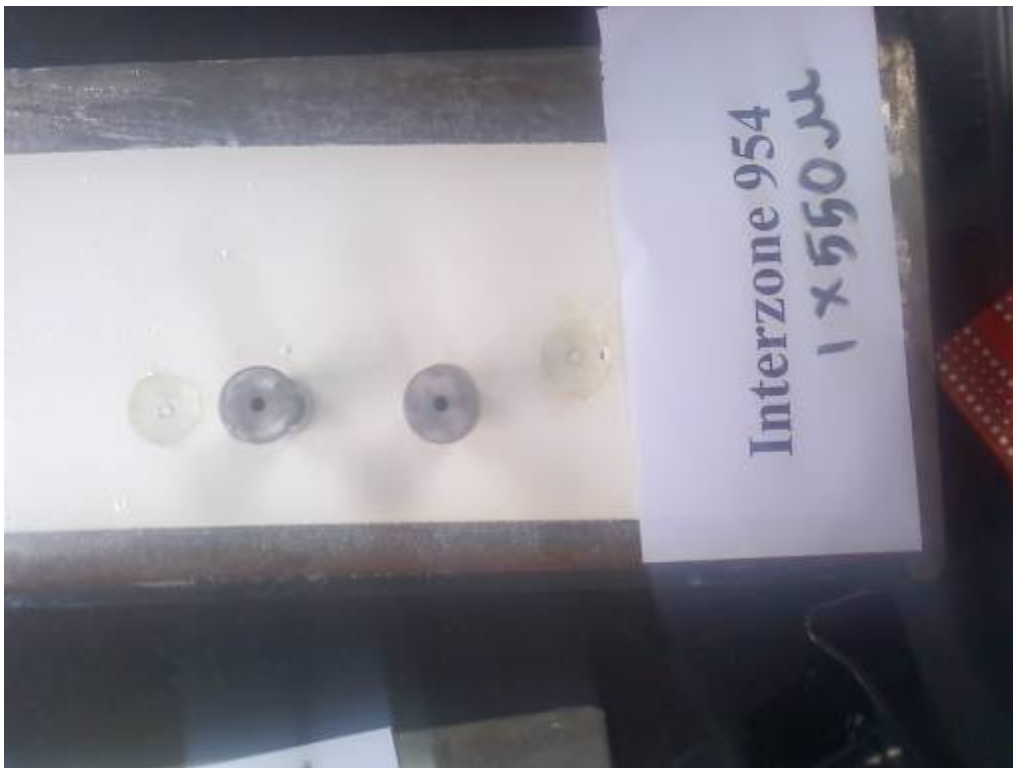
Interzone 954 after Adhesion Pull off ...

| Coating | Minimum Specification | Result | Comments |
|---|---|---|---|
| Interzone 954 Without Scoring | 5 MPa | 5 MPa | Glue Failure 100% |

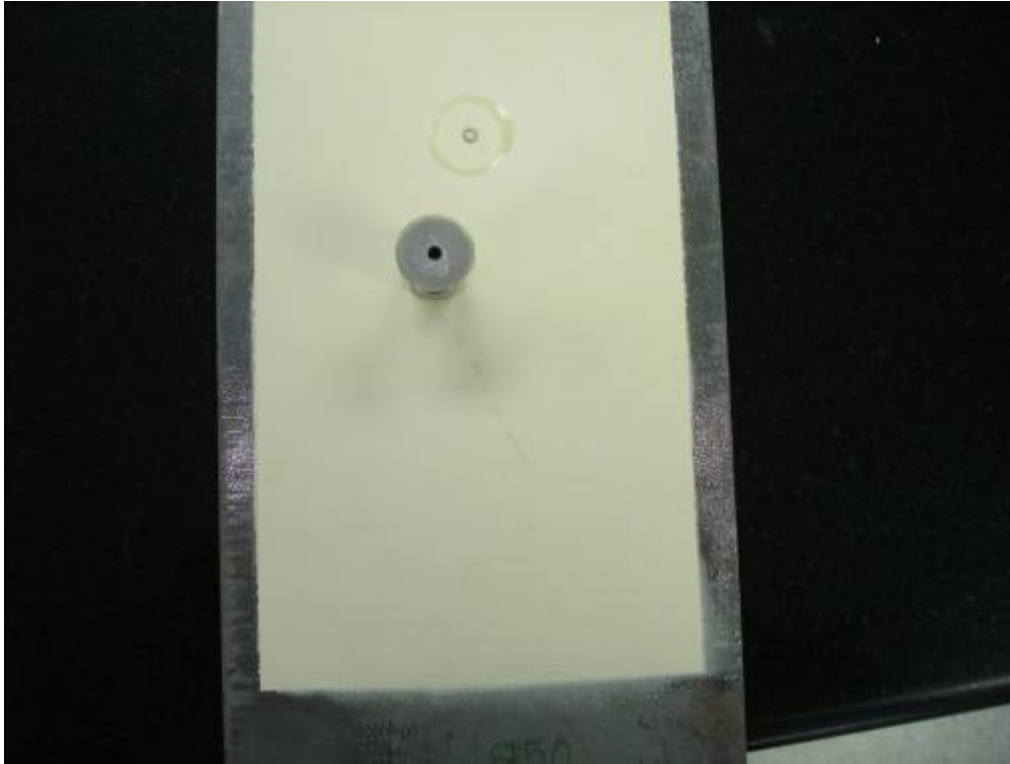
Interline 850 after 120°C 72 Hrs + Quenching + 48 Hrs @ 120°C & Quenching + 72 Hrs at Room Temperature
